**COLUMBIA COLLEGE CHICAGO
CAMPUS PRESERVATION PLAN**

Volume XI

1104 South Wabash Avenue

**Submitted by
McGuire Iglesias & Associates, Inc.**

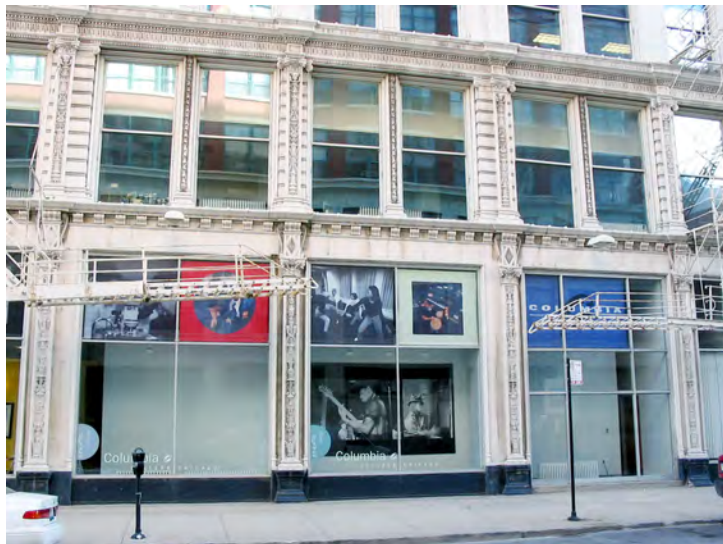
of flat wall surfaces, accentuated at the center and corner bays with simple pilasters and projecting belt-courses. The facades are capped with an ornate terra cotta cornice. The terra cotta wall surface, cornice and parapet appear to be in fair condition with some areas of chipped, cracked and displaced terra cotta.

North façade, first and second floors

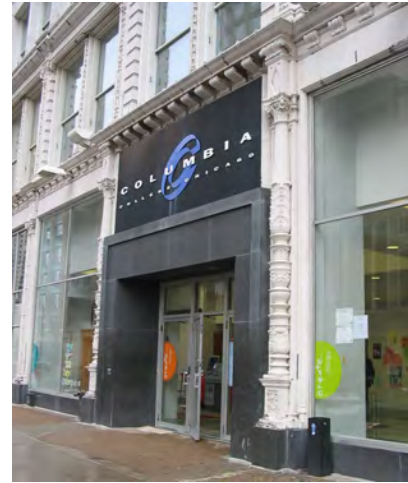
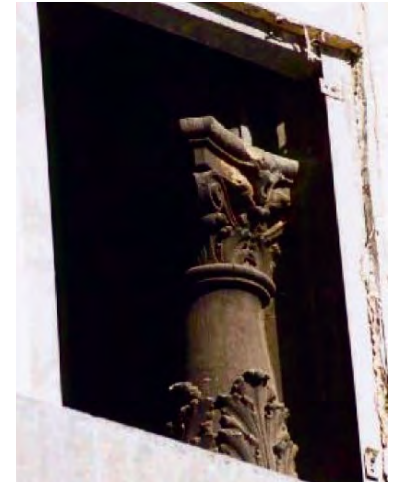
Remodeled Wabash Entrance (left) and inspection opening showing original terra cotta above entrance (right). Inspection opening (showing original terra cotta ornament behind granite) and photo by SAS Architects & Planners

- Inspect the terra cotta for cracks and deteriorated anchors. Repair and tuckpoint as necessary.
- Plan for a comprehensive terra cotta façade restoration including the removal of paint and soiling; repair and replacement of deteriorated terra cotta and anchors as necessary; tuckpointing with an appropriate mortar; and new sealants at wash joints and windows.
- Restore Wabash Avenue Entry. Remove the granite door surround and base and repair or replace the terra cotta at these locations to restore the historic appearance of the building. Original terra cotta remains behind the panels above the main

entrance. Repair the existing terra cotta and replicate in kind missing or severely damaged material using existing terra cotta and historic documentation as a guide.

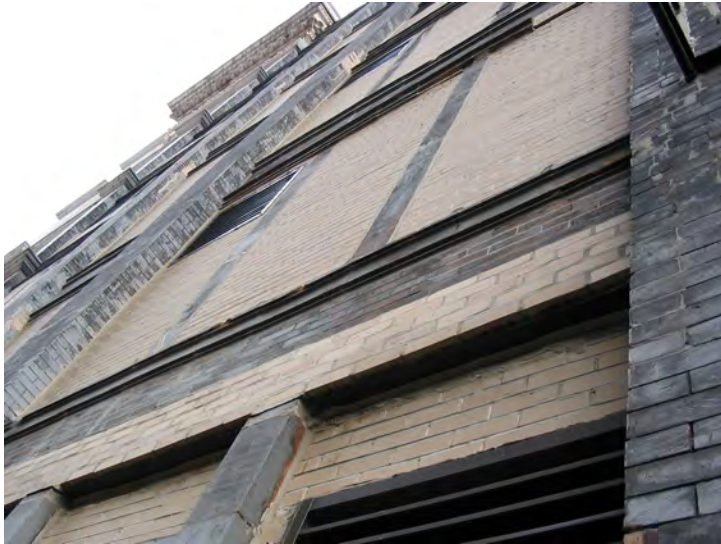
View of bricked-in window openings and existing terra cotta trim and mullions at upper floors of West (alley) façade

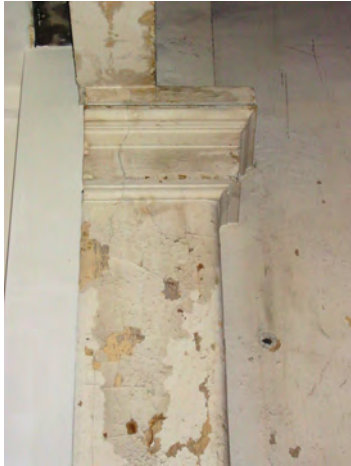
Detail of plaster wall and capital in the West Stairway

- Repair plaster in West Stairway, including walls, ceilings and ornamental column capitals.
- There should be continued preservation of historic materials and configuration.

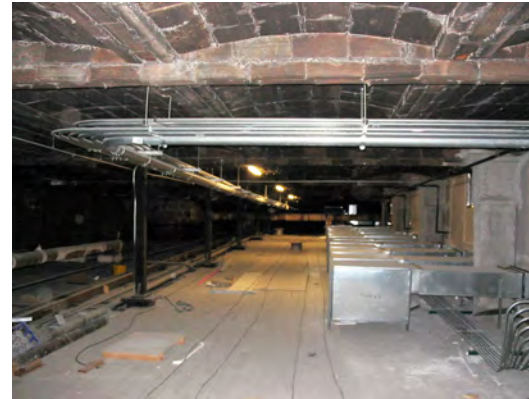
View of attic showing steel and clay-tile structure.

- Inspect and repair roof framing system (clay tile arch construction) visible in attic.

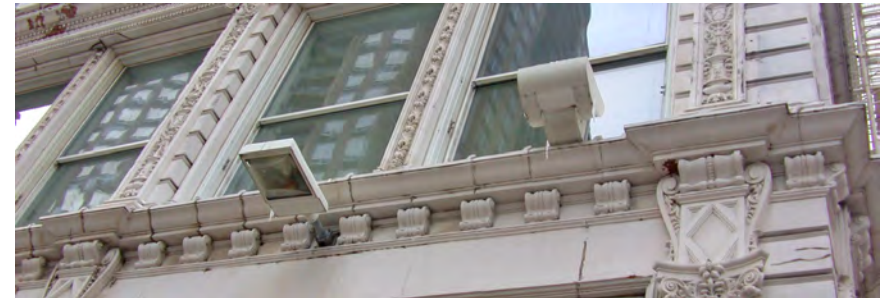
Exterior elevation – HID floodlights mounted to building façade.

- The HID floodlights are a significant intrusion to the architectural character of the building. These fixtures should be removed to restore the original appearance of the facade. If illumination of the façade is desired, a new lighting system should be designed which integrates with the architecture or adjacent street lighting poles.
- The downlights above the east entry, though not original, may be desired for nighttime safety. If, in the course of

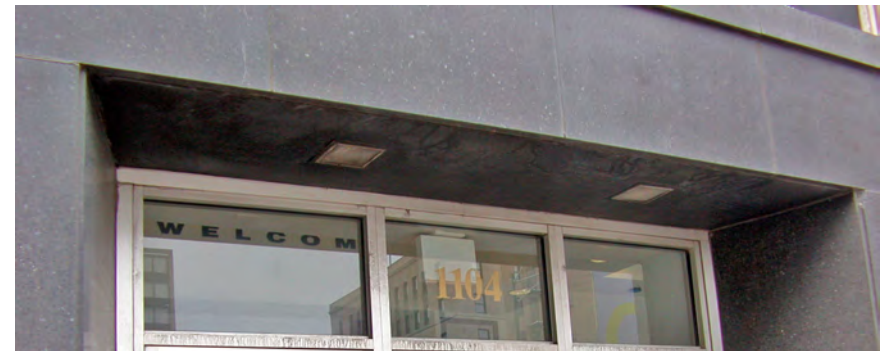
East elevation – incandescent downlights above east entry.

restoration, the black granite is removed, care should be taken to replace the downlights with a lighting scheme which is sensitive the architectural character of the building.
