**COLUMBIA COLLEGE CHICAGO
CAMPUS PRESERVATION PLAN**

Volume XI

1104 South Wabash Avenue

**Submitted by
McGuire Iglesias & Associates, Inc.**

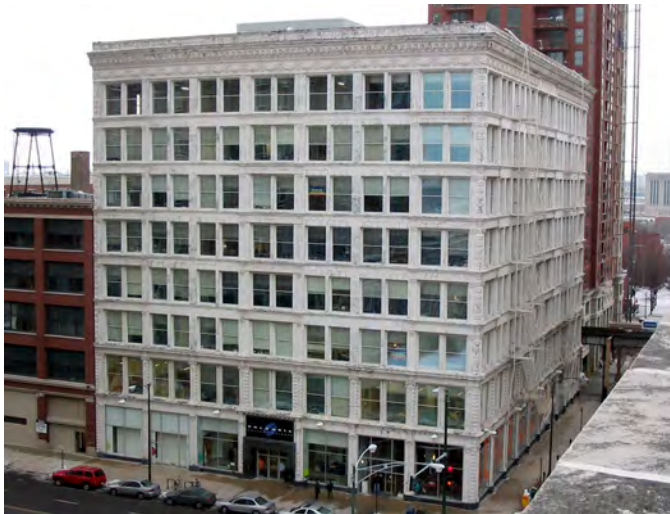
East and north facades

of flat wall surfaces, accentuated at the center and corner bays with simple pilasters and projecting belt-courses. The facades are capped with an ornate terra cotta cornice. The terra cotta wall surface, cornice and parapet appear to be in fair condition with some areas of chipped, cracked and displaced terra cotta.

- Inspect the terra cotta for cracks and deteriorated anchors. Repair and tuckpoint as necessary.
- Plan for a comprehensive terra cotta façade restoration including the removal of paint and soiling; repair and replacement of deteriorated terra cotta and anchors as necessary; tuckpointing with an appropriate mortar; and new sealants at wash joints and windows.
- Restore Wabash Avenue Entry. Remove the granite door surround and base and repair or replace the terra cotta at these locations to restore the historic appearance of the building. Original terra cotta remains behind the panels above the main

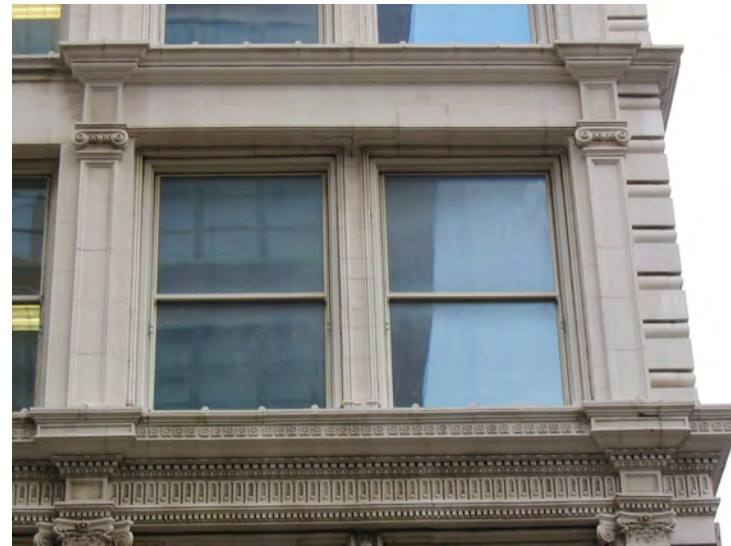
Upper floor façade detail

- Upper floor windows: when the replacement of the non-original windows is considered, the new units should replicate the appearance of the original. This work should be done based on available historic documentation and should incorporate restoration of both materials and design. Any extant original window elements should be retained.
- Returning the ground floor storefronts to their historic configuration will improve the integrity of the primary facades. This work should be done based on available historic documentation and replicate the original design and materials.
- The exterior fire escapes are part of the historic of the building and should be retained.
- Avoid contact with detrimental deicing salts that can damage the wall and entry floor surfaces.

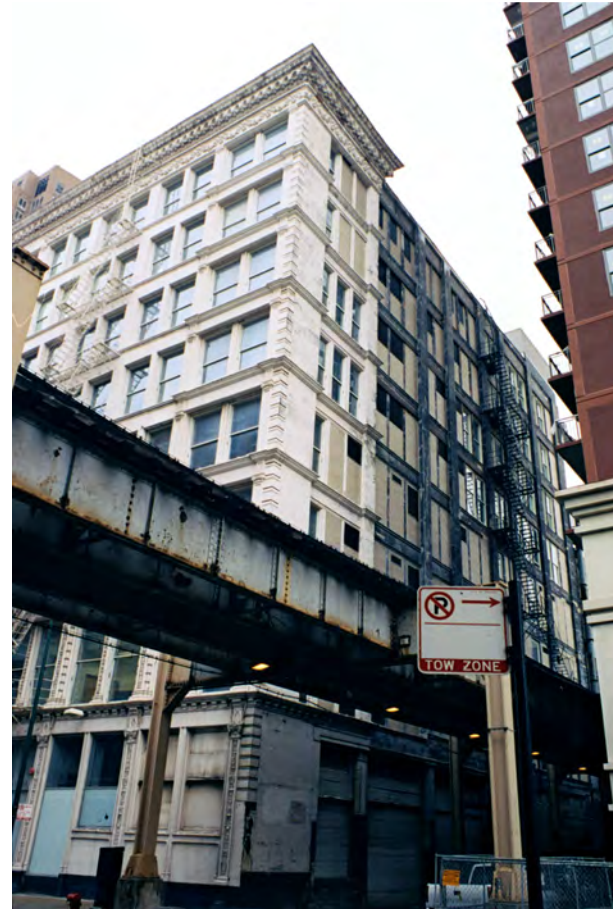
Alterations include the replacement of original windows on all facades and bricked-in window openings at the return. Three original windows remain, one at the return and two at the west end of the north façade. At the first floor, the storefronts, storefront base, and doors have been replaced. The Wabash entrance has been remodeled with stone panels at the original decorative terra cotta transom, a black granite surround at new entrance doors and black granite base on the east façade and

Return at alley (west) facade

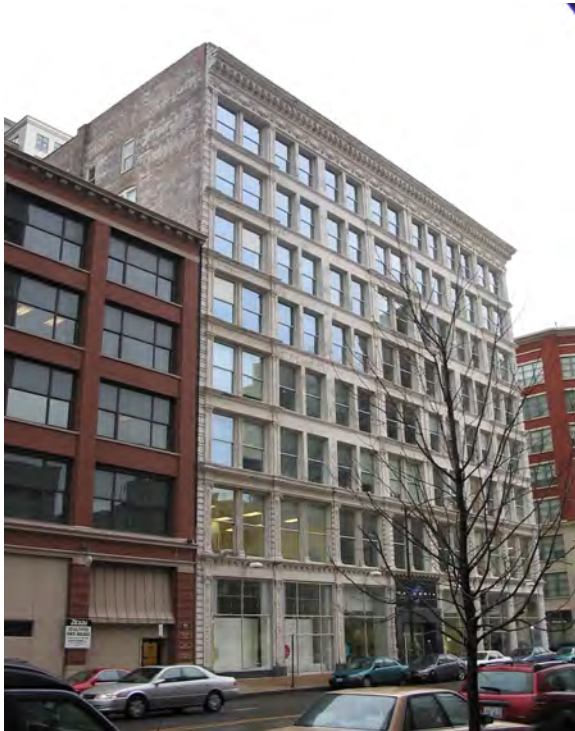
Secondary elevations of the 1104 Wabash Campus consist of the south and west facades. The south façade is visible above the neighboring, five story building and is clad in common brick. Windows along this façade are metal replacements.

Portion of south façade (side wall) visible from street

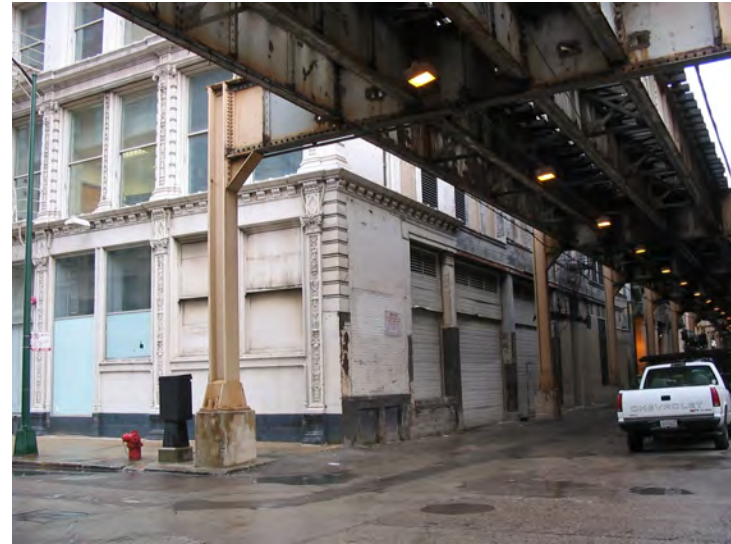
Alley (west) façade

The west facade faces an alley and is of brick with terra cotta belt-courses between each floor and terra cotta mullions between the original window openings. An original fire escape with ornamented landings is located near the center of the façade. A newer brick wall was constructed to enclose the south half of the loading dock, which has been converted into interior space. Original terra-cotta capitals remain at this wall. A service entry is located near the center of the façade and overhead garage doors are located between columns at the north half of the façade. Most window openings on this façade have been bricked in, filled with louvers, or both. The remaining windows are metal replacements.

- The west bays have had air handling equipment for at least the past 30 years. While it would be difficult to eliminate the west ventilation openings, they could be incorporated into a more acceptable replacement window/panel system.

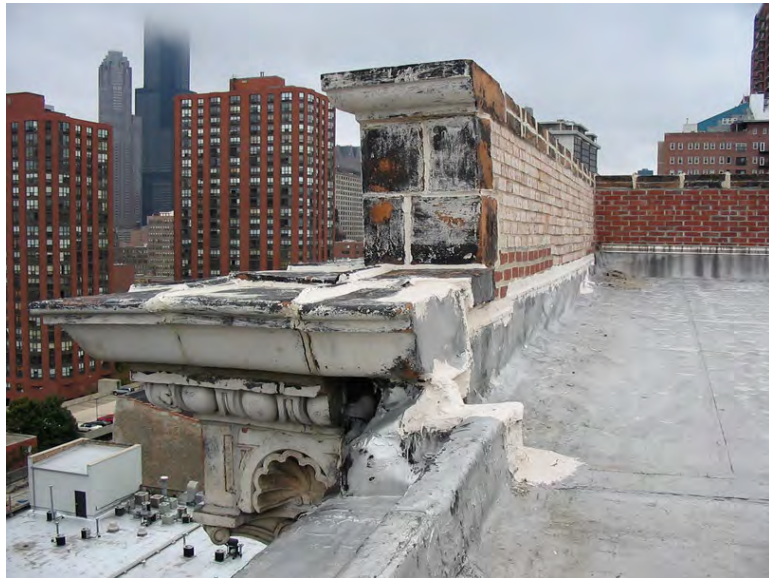
Edge of west parapet viewed from roof

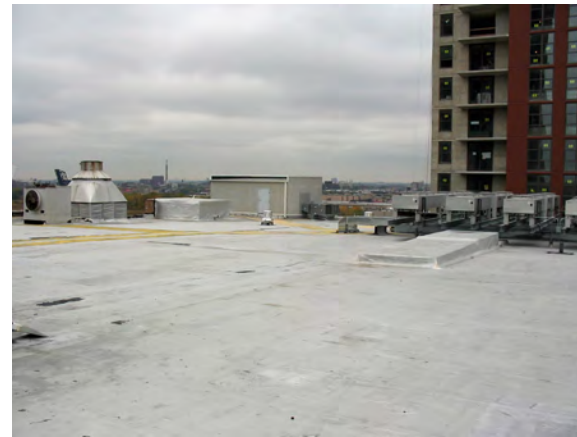
Roof view looking southwest

- Inspect and repair roof framing system (clay tile arch construction) visible in attic.

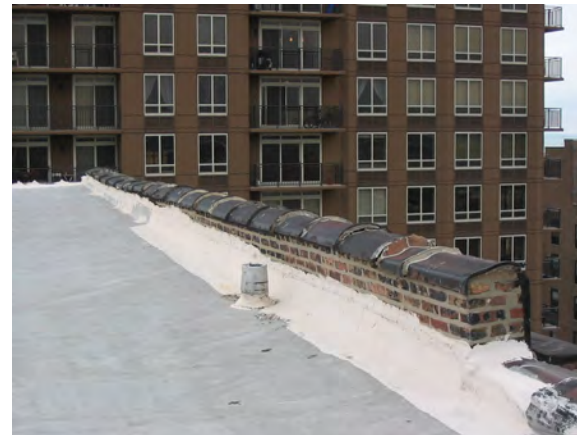
Portion of south parapet wall looking east

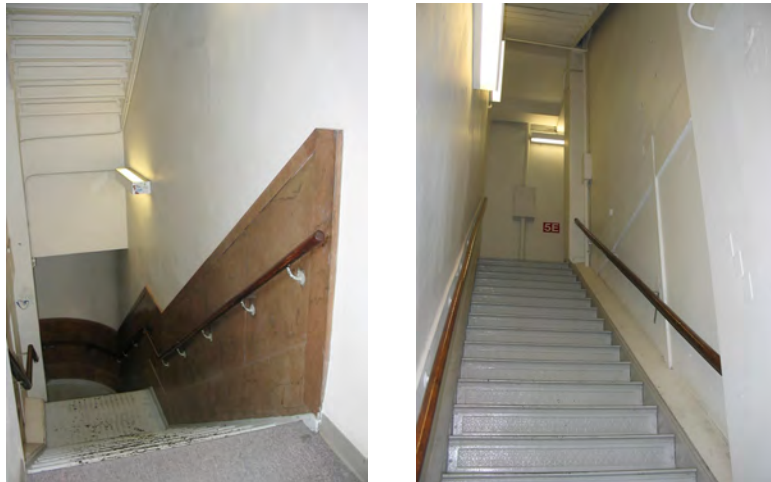
East Stairway looking down from the second floor (left) and looking up at typical flight (right)

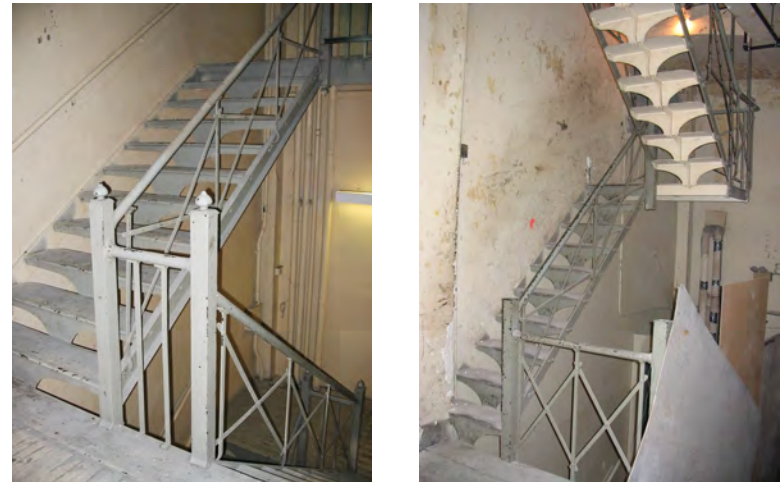
West Stairway, typical configuration (left) and view of the more narrow stairs up to the roof (right)

- Repair plaster in West Stairway, including walls, ceilings and ornamental column capitals.
- There should be continued preservation of historic materials and configuration.

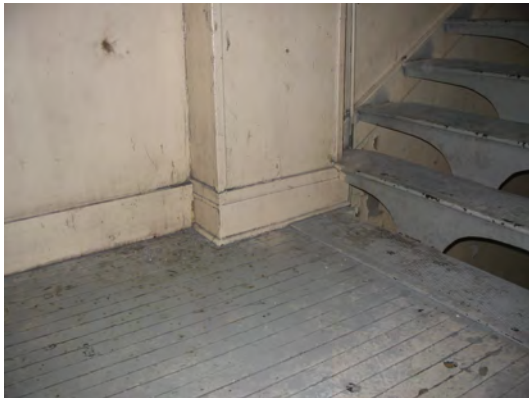
Detail of wood floor and wall trim at the West Stairway

Historic elements have been rated for preservation and appear to be in good condition. These include the cast and wrought iron stair elements, and the marble wainscoting, wood wall trim and floor, and plaster elements.

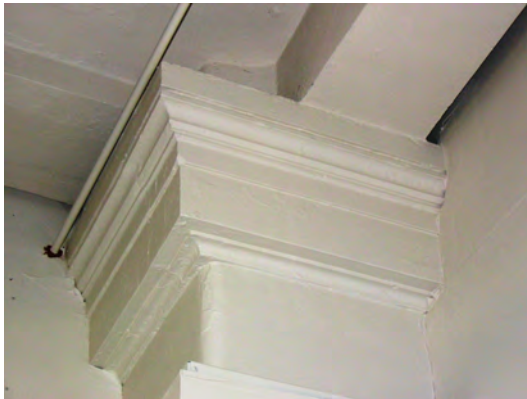
Detail of plaster pier capitals that can be found throughout the building

- Continued preservation of the plaster covered, exposed floor structure and ornamental column capitals, is recommended. Although dropped ceilings have been and are being installed to hide ductwork and wiring, preservation of the plaster leaves the option for uncovering it later.
- Organize and locate the newspaper boxes, free standing signage and other containers to minimize a cluttered appearance.
